Miragoane, Haiti

OCT 08

**Field Visit to Ennery Bridge,
Gonaives, Montrouis Bridge
and watershed, Haiti**

29-31 OCT 08

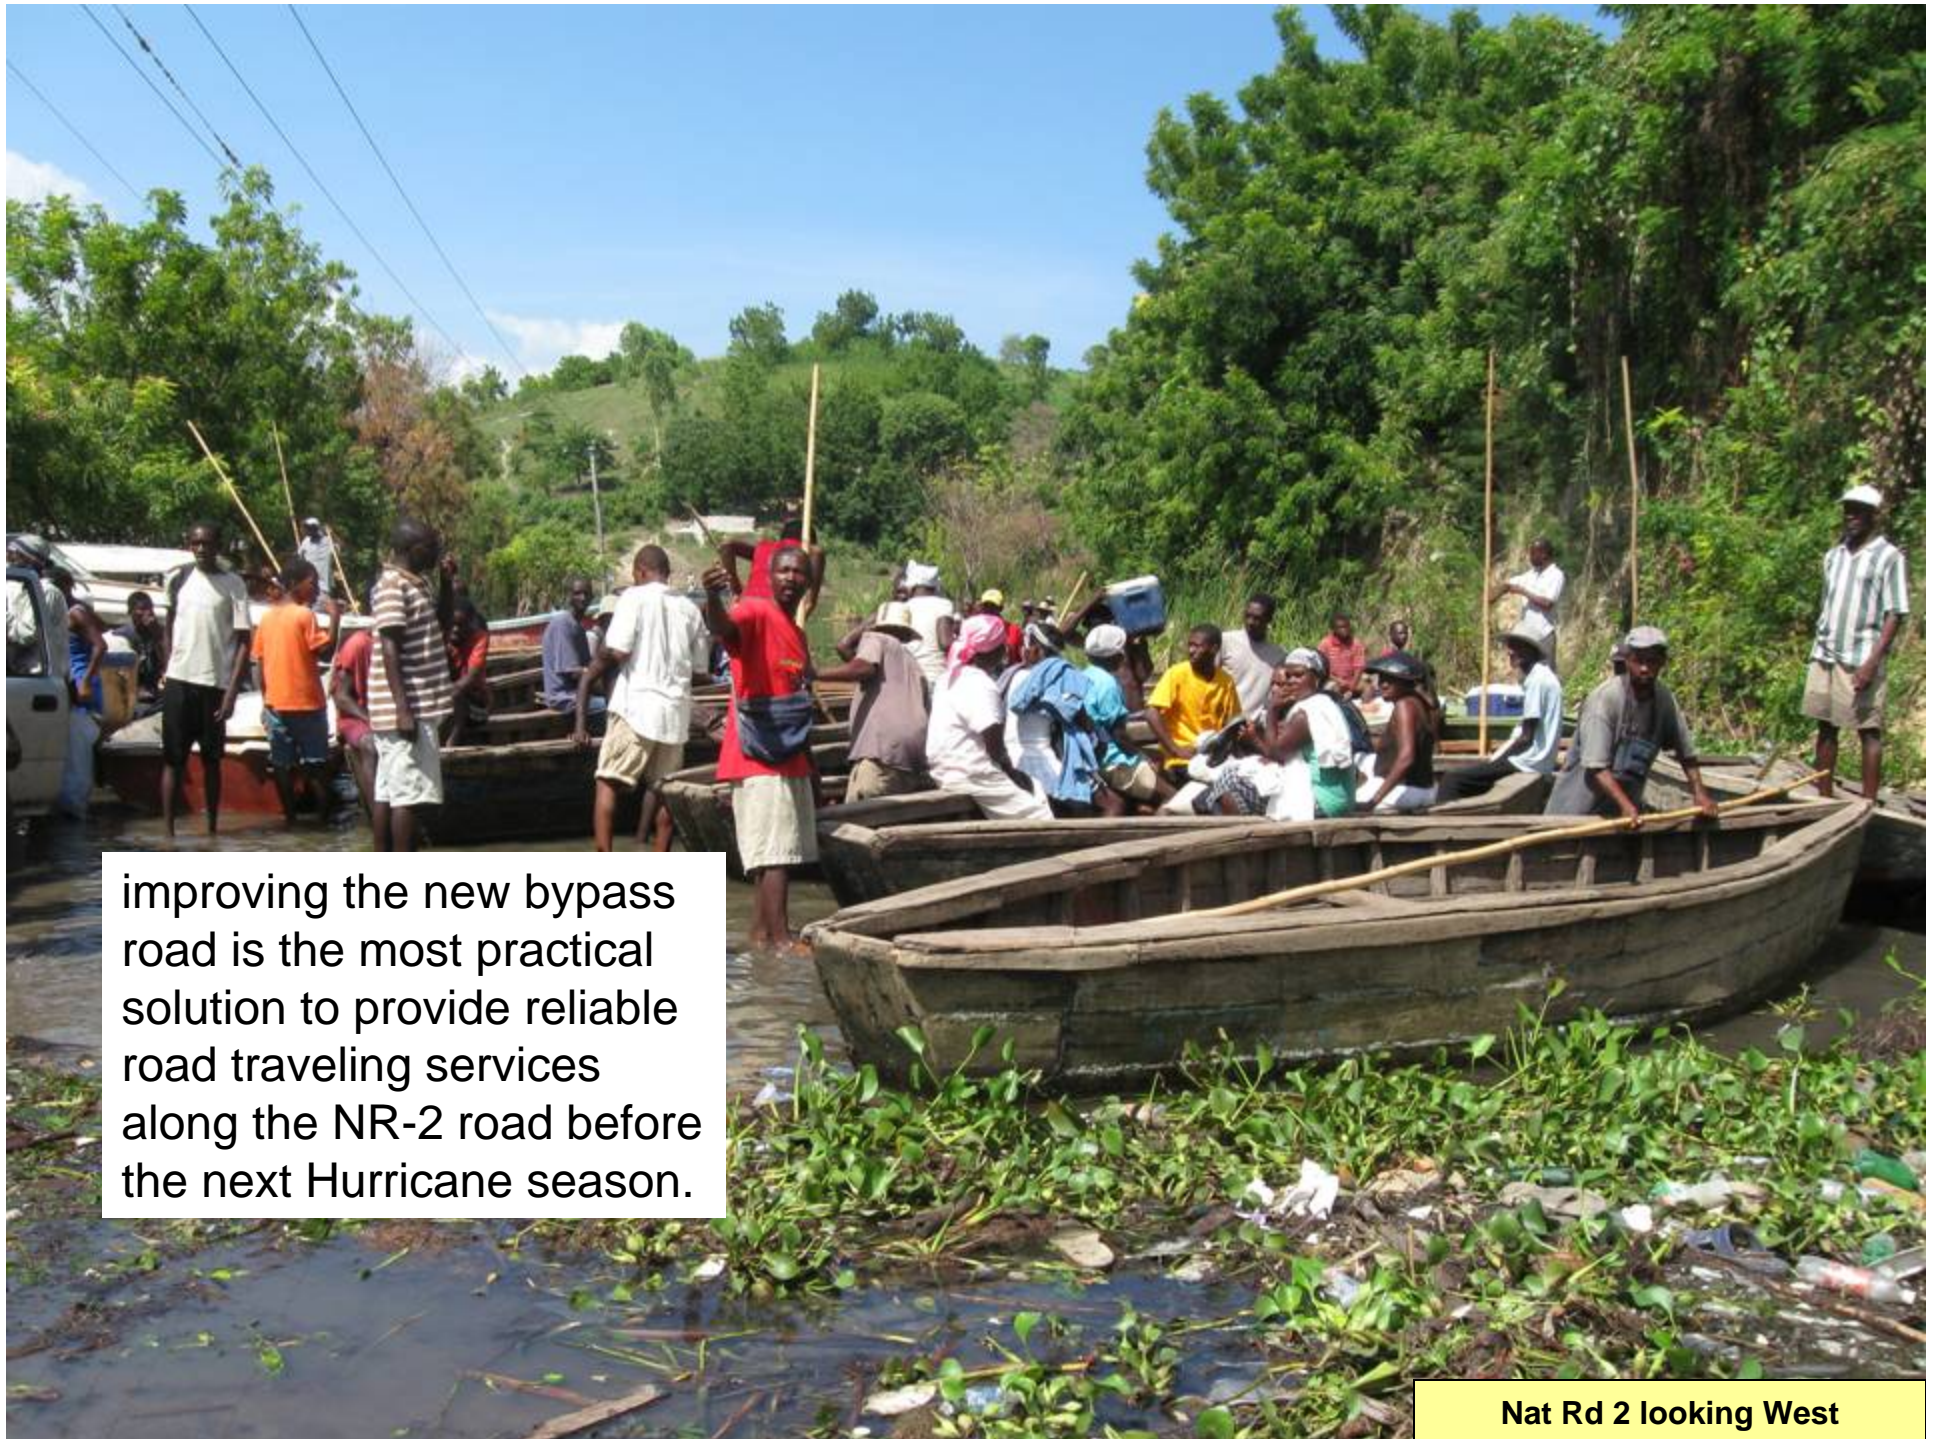
Damage: National Route 2 is
blocked by rising waters of Lake
Miragoane

improving the new bypass road is the most practical solution to provide reliable road traveling services along the NR-2 road before the next Hurricane season.

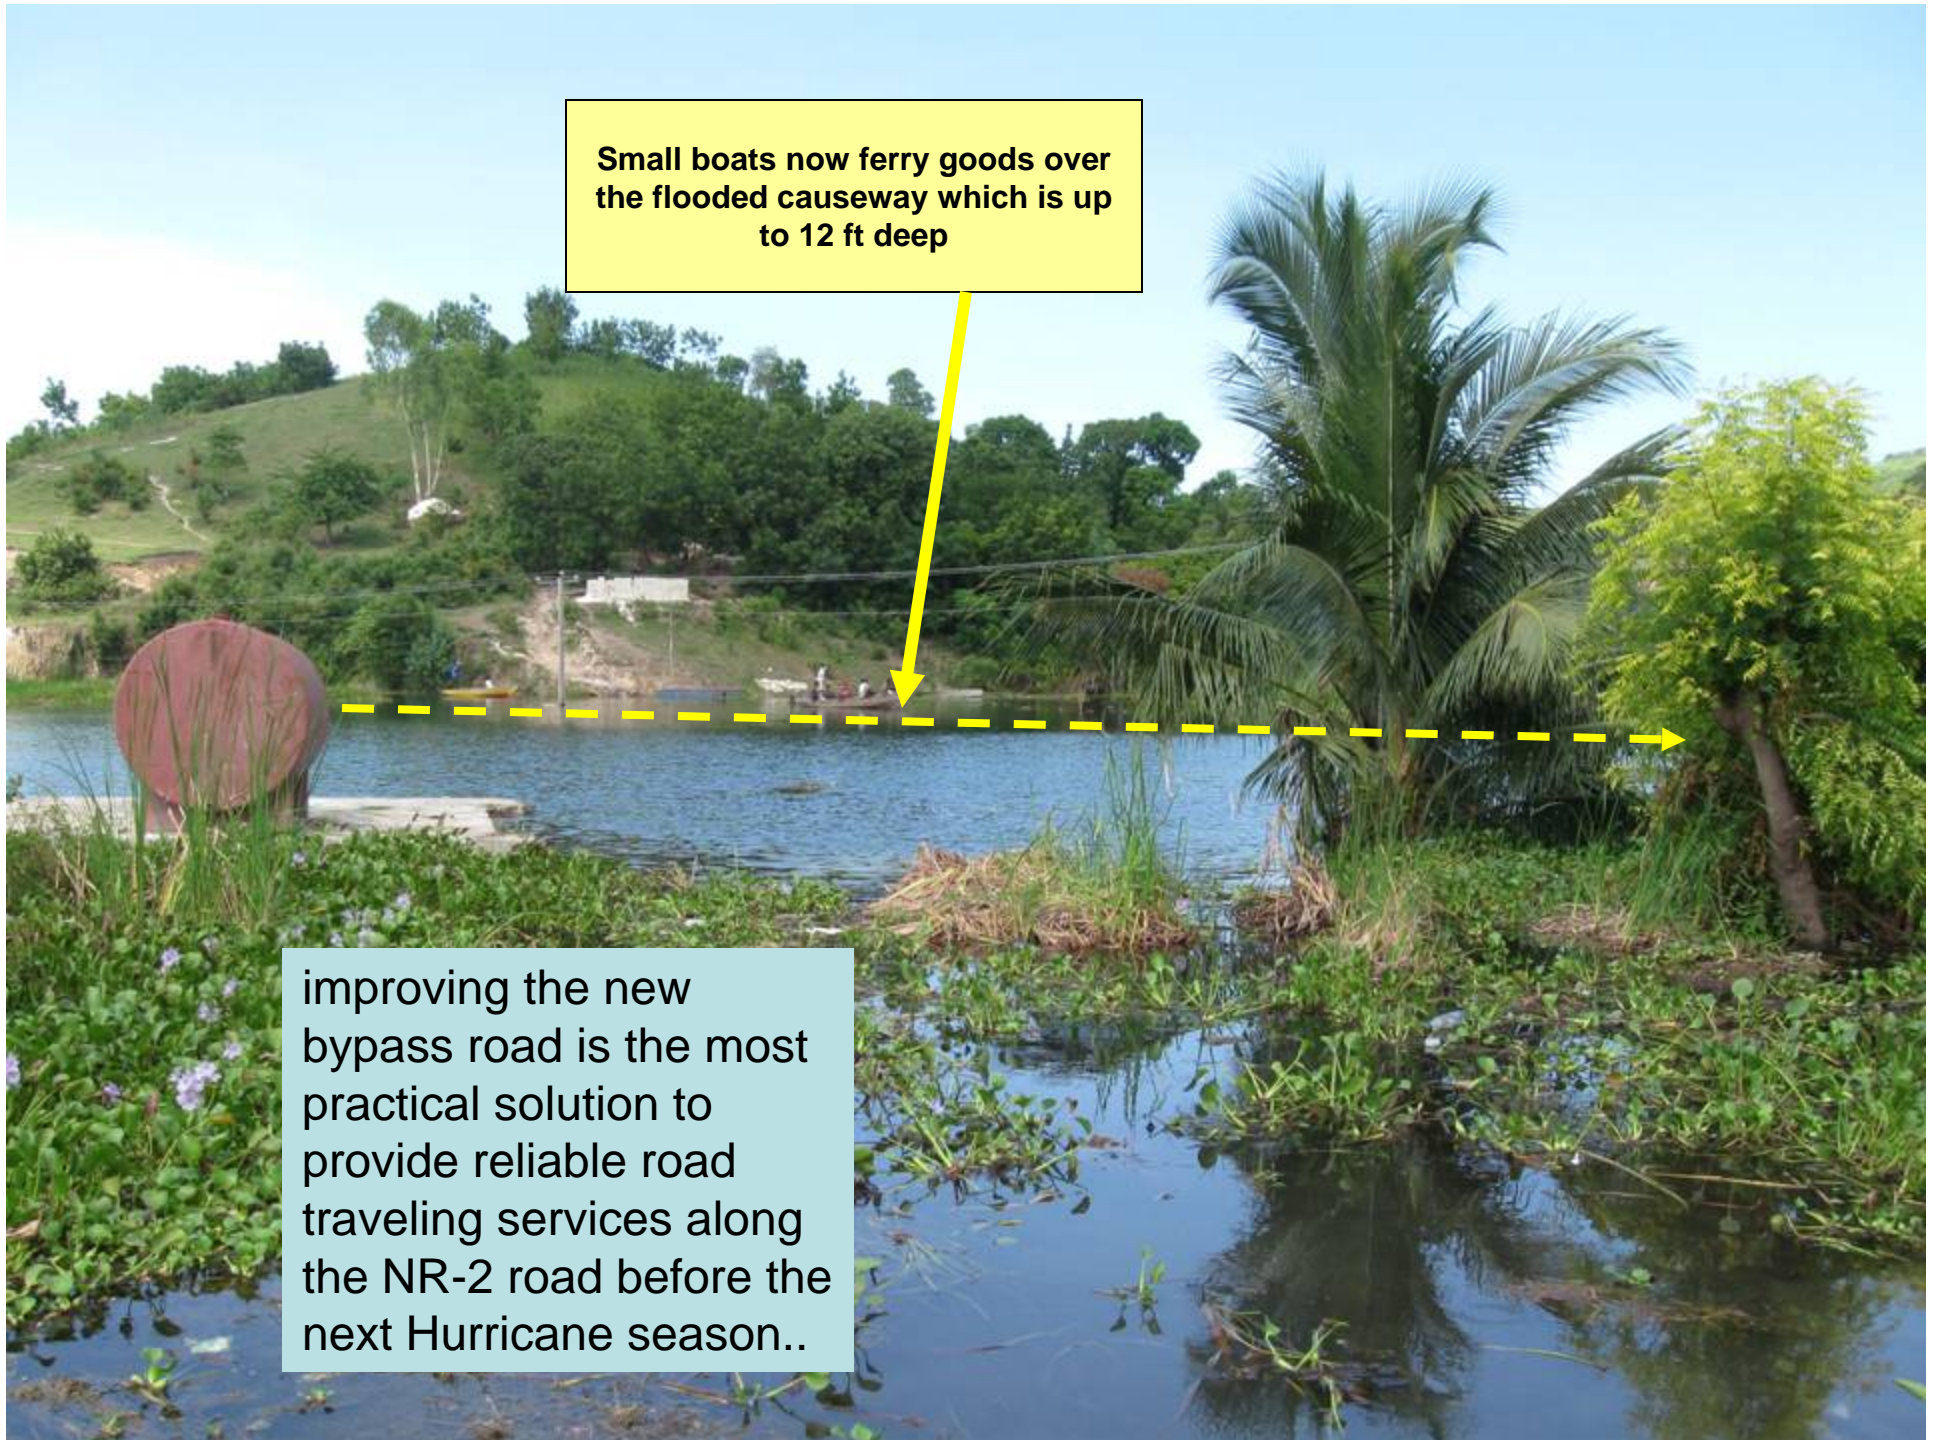
Lake Miragoane has flooded extensive agricultural areas

Small boats now ferry goods over the flooded causeway which is up to 12 ft deep

improving the new bypass road is the most practical solution to provide reliable road traveling services along the NR-2 road before the next Hurricane season..

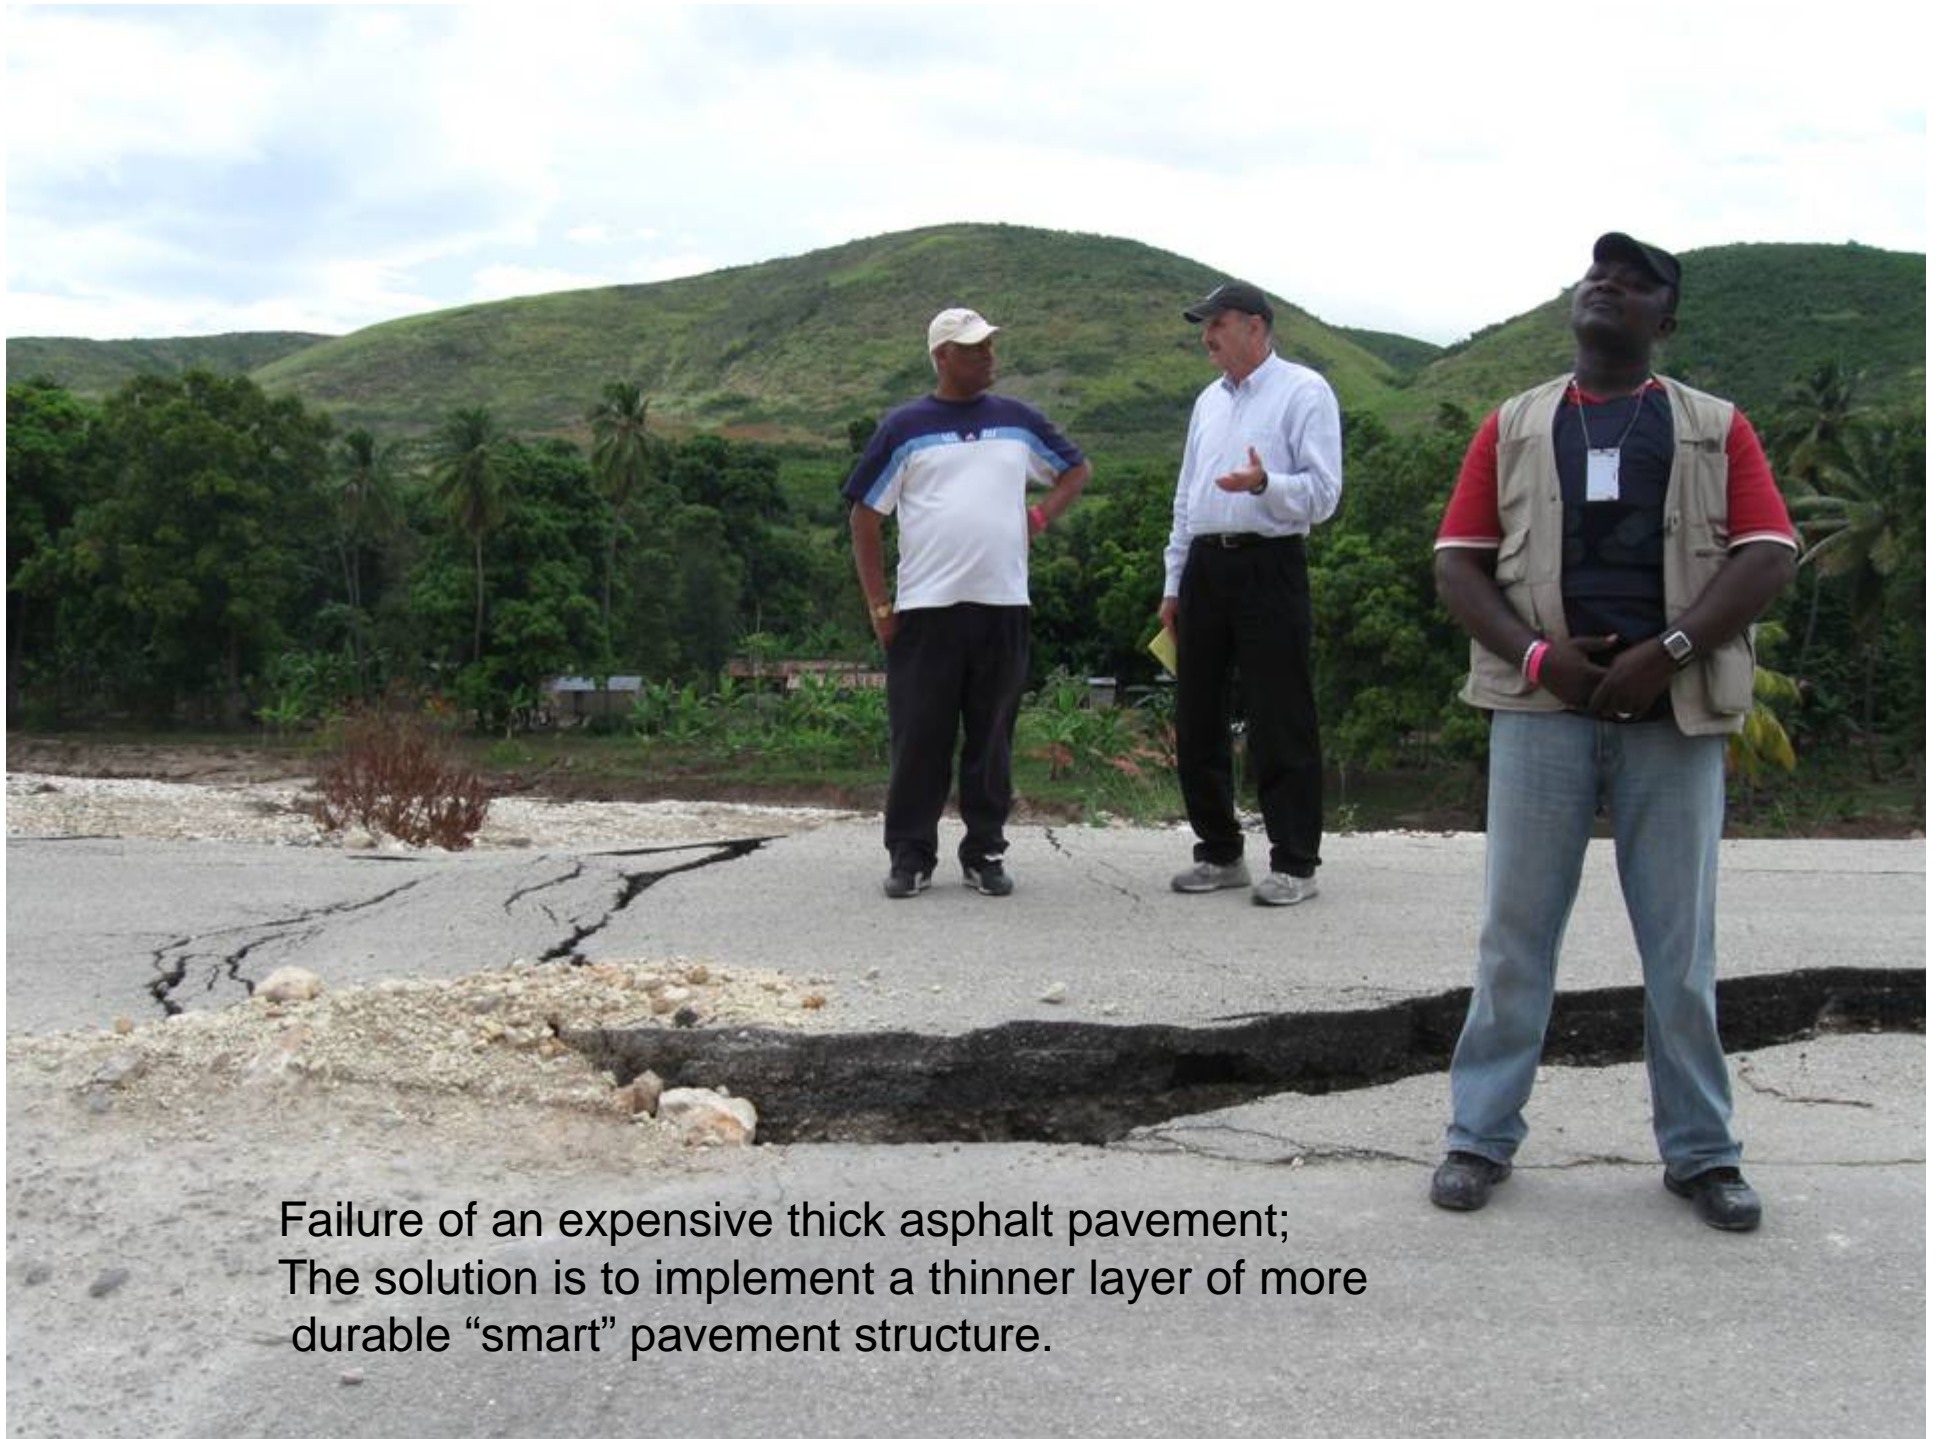
Failure of an expensive thick asphalt pavement;
The solution is to implement a thinner layer of more
durable “smart” pavement structure.

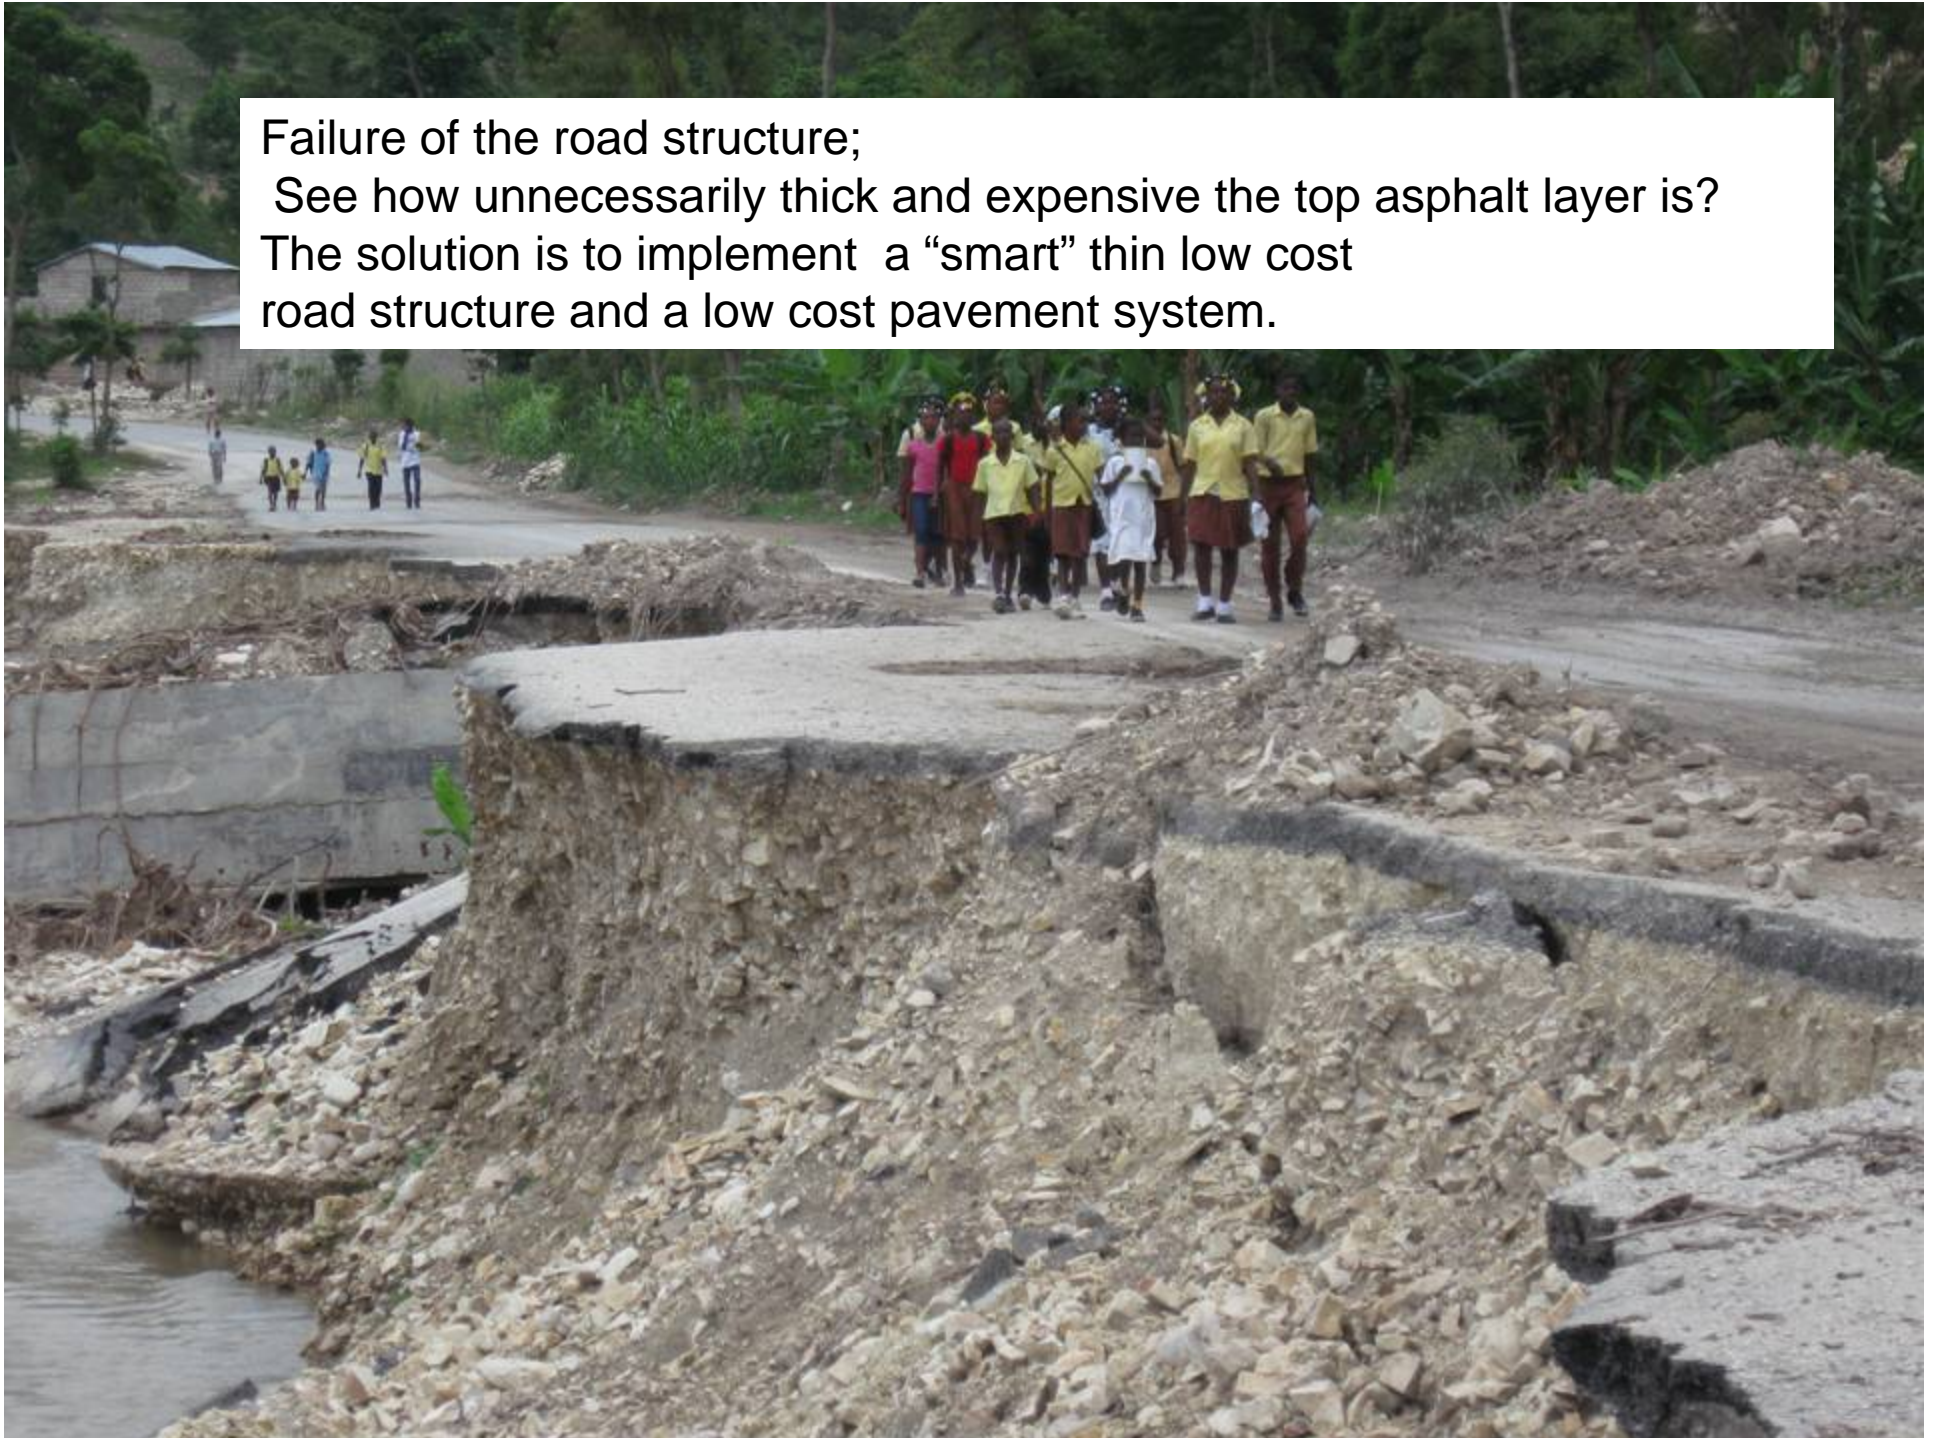
Failure of the road structure;

See how unnecessarily thick and expensive the top asphalt layer is?
The solution is to implement a “smart” thin low cost road structure and a low cost pavement system.
